**21 Murvagh Close
Cheltenham
GL53 7QX**

Type 2 Survey and Asbestos Register

November 2004

Report type: Survey and Assessment of Asbestos Containing Materials

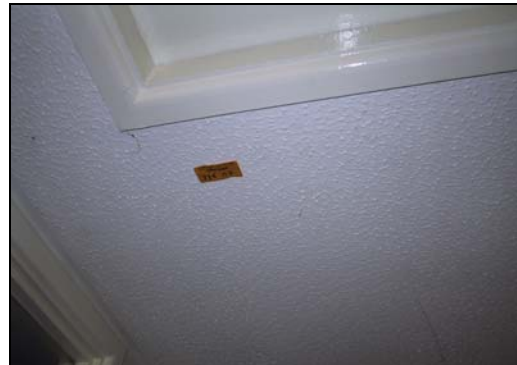
Sample no: 336.02

Item: Decorative coating-Artex
Location: Landing ceiling

Lab result: Chrysotile

Material Risk Score: 3 Product Type: 1
Damage/deterioration: 1
Surface treatment: 0
Asbestos type: 1

Priority Risk Score: 4 Occupant activity: 0
Likelihood of disturbance: 1
Exposure potential: 2
Maintenance activity: 1

Total Risk Score: 7

Comments: Periodically inspect to ensure no damage (Artex coatings contain a small percentage of asbestos in their make up.)

Recommended action: Manage in place
– periodically inspect

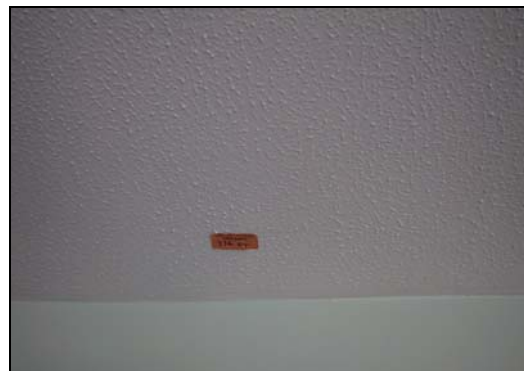
Sample no: 336.04

Item: Decorative coating-Artex
Location: Kitchen

Lab result: Chrysotile

Material Risk Score: 3 Product Type: 1
Damage/deterioration: 1
Surface treatment: 0
Asbestos type: 1

Priority Risk Score: 5 Occupant activity: 1
Likelihood of disturbance: 1
Exposure potential: 2
Maintenance activity: 1

Total Risk Score: 8

Comments: Periodically inspect to ensure no damage (Artex coatings contain a small percentage of Asbestos in their make up.)

Recommended action: Manage in place
– periodically inspect.

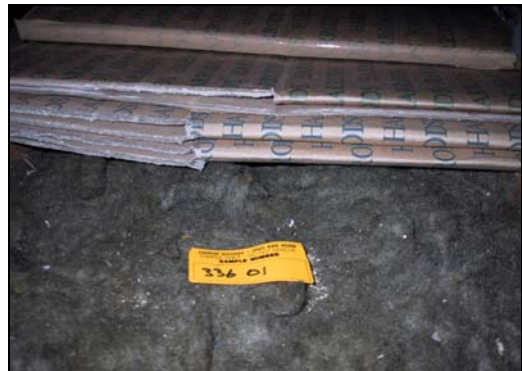
Sample no: 336.01

Item: Joist infill insulation

Location: The Loft

Lab result: NAD (no asbestos detected)

Comments: No Asbestos detected- Inert material

Recommended action: None required

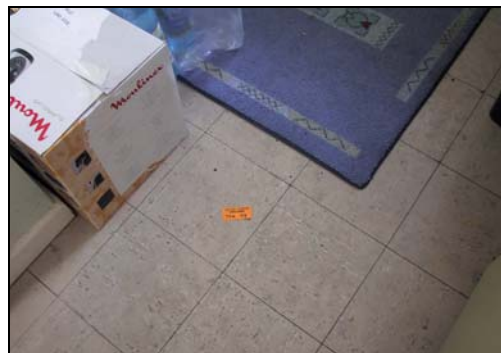
Sample no: 336.03

Item: Vinyl Floor Tiles

Location: The Kitchen

Lab result: NAD

Comments: No Asbestos detected – Inert material

Recommended action: None required
